Izmit Sultan Abdülaziz Imperial Hunting Lodge: Restoration following the 1999 earthquake

Yegan KAHYA*

Abstract:

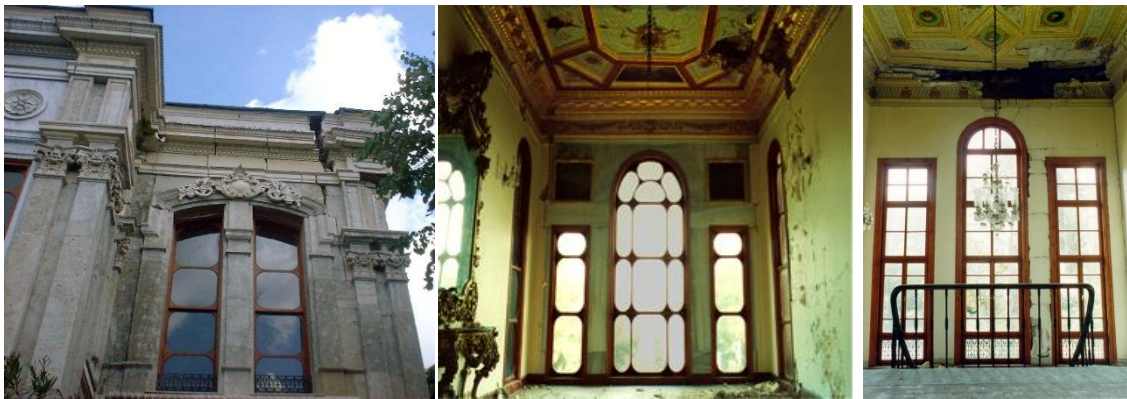
The ageing of the building materials, the use of inappropriate techniques and materials in repair interventions, the effect of the earthquakes and the building's following exposure to climatic conditions, and the lack of maintenance were the major causes for the damages observed on the building. Due to the continuous interaction of these causes, the deterioration has increased in magnitude. (Figure 3)

Figure 3. *The condition of the building following the earthquake.*

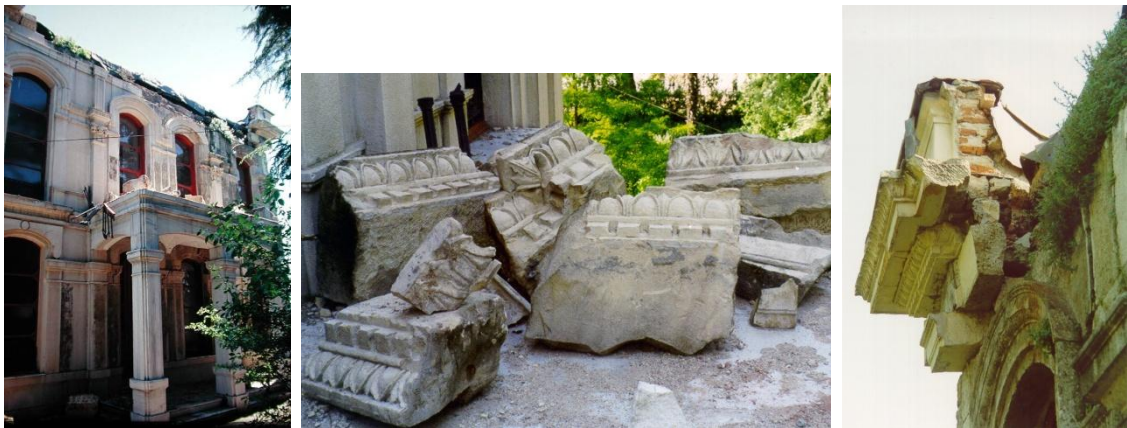
Figure 4. *The view of the east façade with collapsed debris of the cornice; these fragments were classified, numbered and then documented in detail with the aim of re-using them in restoration.*

During this intervention, the stones of the cornice were numbered and dismantled and were replaced at their original locations at the end of the work. The elements of the cornice which had detached and fallen down from the east façade were re-used based on the information obtained from a detailed inventory and documentation study. Those in good condition were only cleaned whereas those with fragmental losses were cleaned and completed before they were replaced in their original locations. The missing cornice parts were reproduced from the original material. Following the completion of the cornice and parapet walls at their original level and in their original form, the exterior faces of the parapet walls were plastered using a mixture determined through laboratory analysis. (Figure 12)

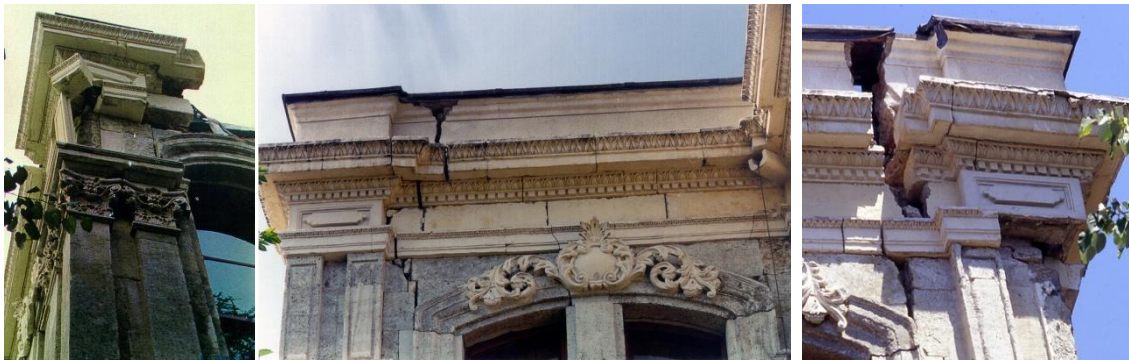
façade was the roof parapet, especially on the east and west corners. (Figure 5) The corners of the parapet walls were cracked and separated as much as 30cm. The exterior and interior walls of the building bore cracks of various shapes in 0-7cm range whereas some leant as much as 10cm from the vertical. In addition to lost wall cladding panels, the crack sides were fully detached and the fragments were about to fall near the corners. There were vertical cracks of different shapes and sizes along the parapets on the side façades as well. (Figure 6) The cross and barrel vaults covering the smaller spaces on the north wing also showed cracks, and their plaster was partially lost.

Figure 5. Deep cracks, detachment and material losses at cornice level (increasing in magnitude toward the building corners).

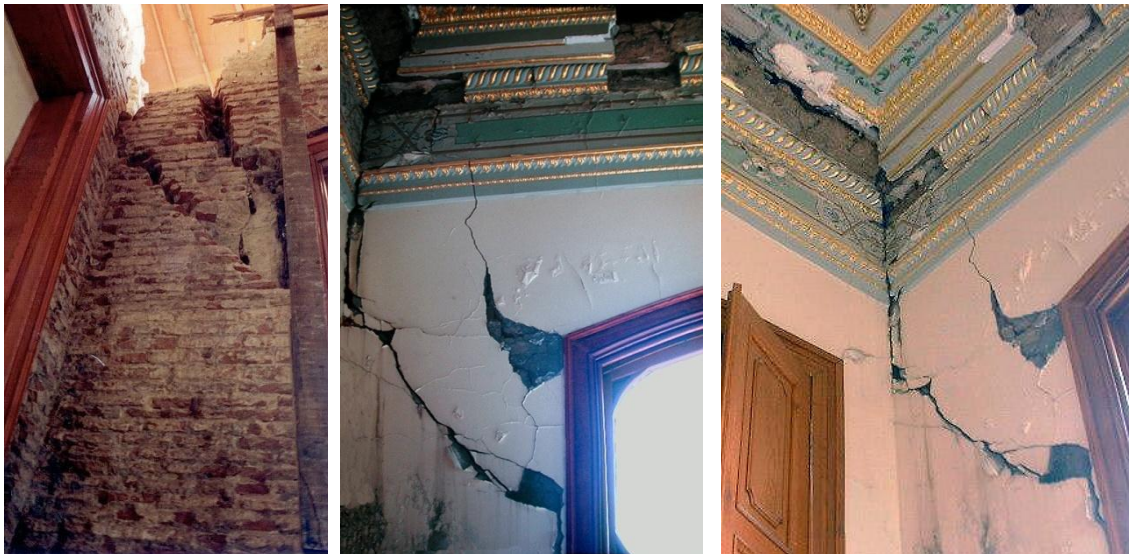
Figure 6. The cracks observed on the load bearing walls underneath the stone cladding.

There are visible cracks of different sizes on the exterior stone cladding on the façades, originating in the roof parapet and running down toward the tops of the window openings. In order to determine whether these cracks also affected the load bearing walls behind the cladding, the stone panels were removed for a width of 25cm on either side of each crack. Those cracks that were also visible on the load bearing masonry and thus were continuous behind the stone cladding were repaired: for cracks and vertical deformations larger than 10mm in width, the masonry on either side was dismantled and this section was rebuilt whereas those narrower than 10mm were filled with fluid mortar injection.

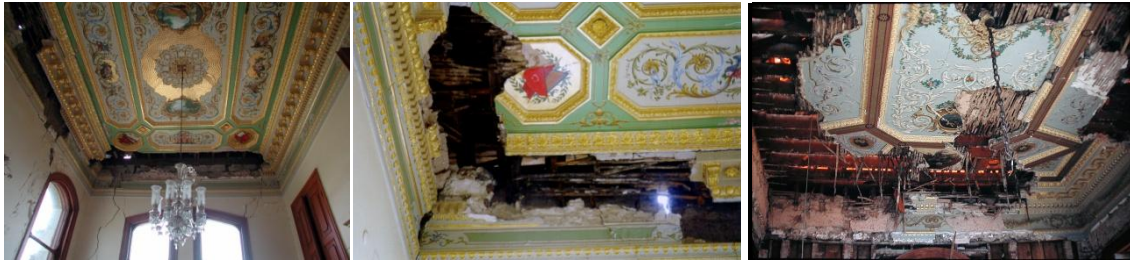
Figure 7. The severe damage on the mouldings and the ceilings.

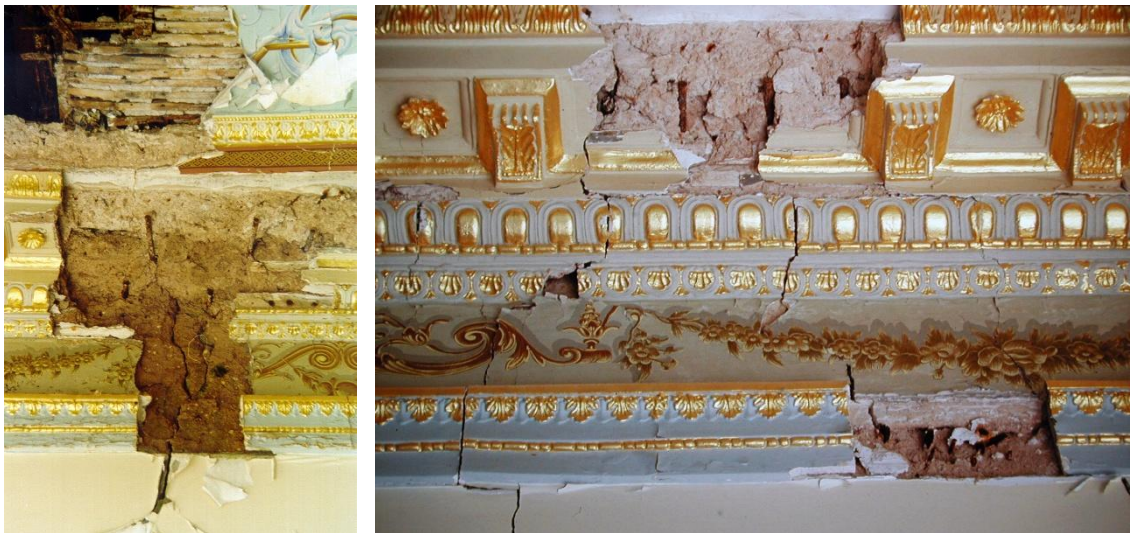
Figure 8. Profile drawings of the mouldings on the wall-ceiling joints, which were severely damaged.

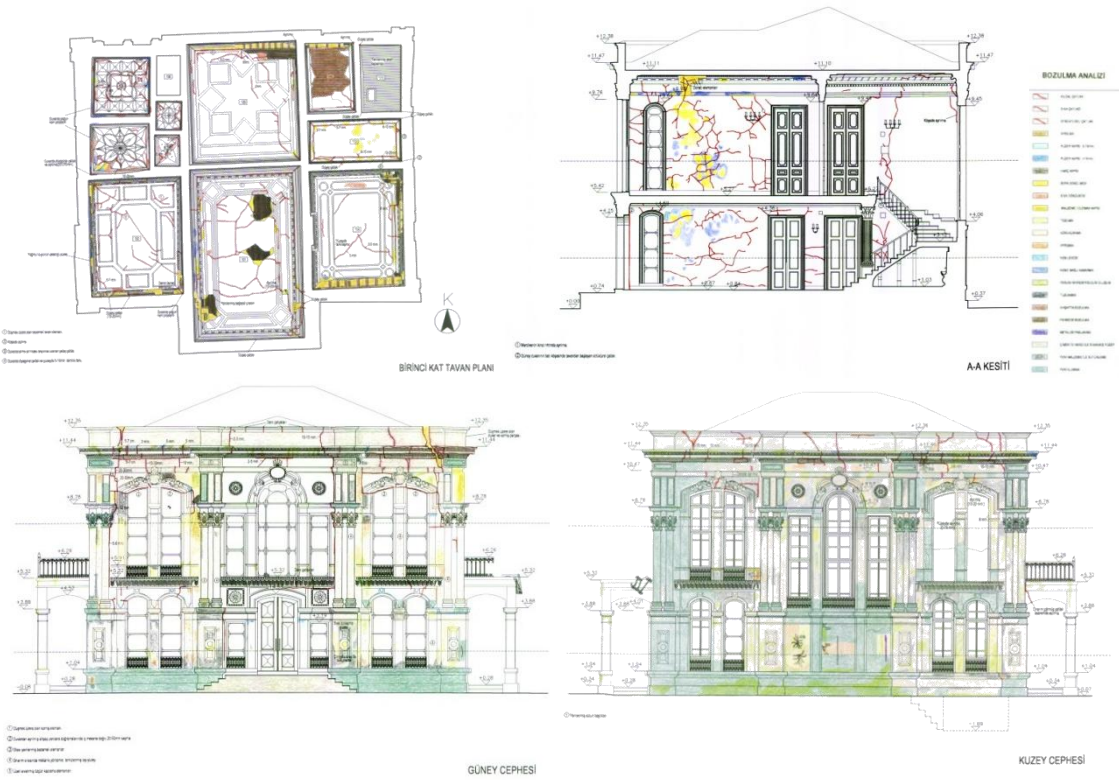
Figure 9. The various types of damage observed on the building were mapped in detail on the survey drawings, including cracks, vertical deformations, losses of architectural/structural elements and material deterioration.

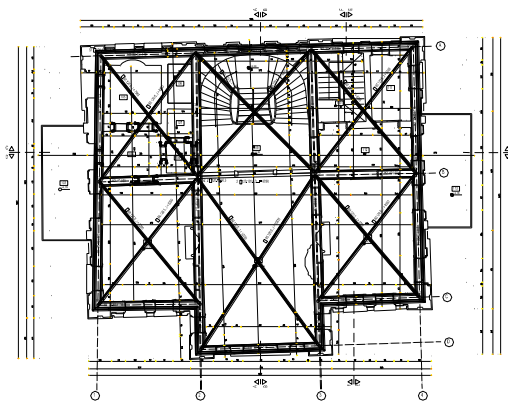
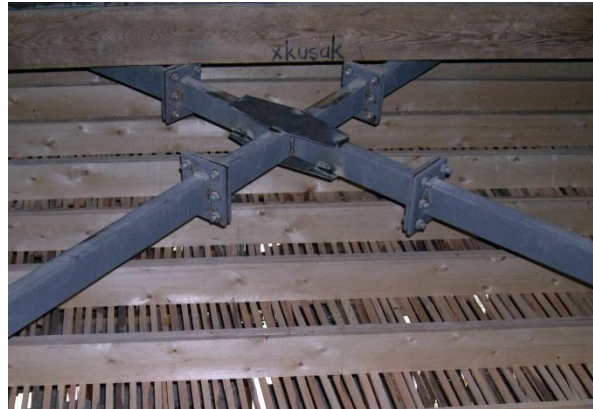
Figure 11. Steel cross-beams were added in the roof space to hinder the outward movement of the main load-bearing walls.

The rebuilding of the brick and stone masonry parapet wall above the roof cornices not only focused on providing a better design for the original construction mistakes but also on making this part of the structure more stable and durable against future earthquakes. In order to stop the outward movement (drifting) of the walls a horizontal beam surrounding the building on the outside and as thick as the load bearing walls was introduced at the upper floor ceiling level; steel cross-beams located in the ceiling structure of each upper floor room were anchored to these horizontal beams on the corners (Sesigür, Çılı, 2009: 215). (Figure 11)

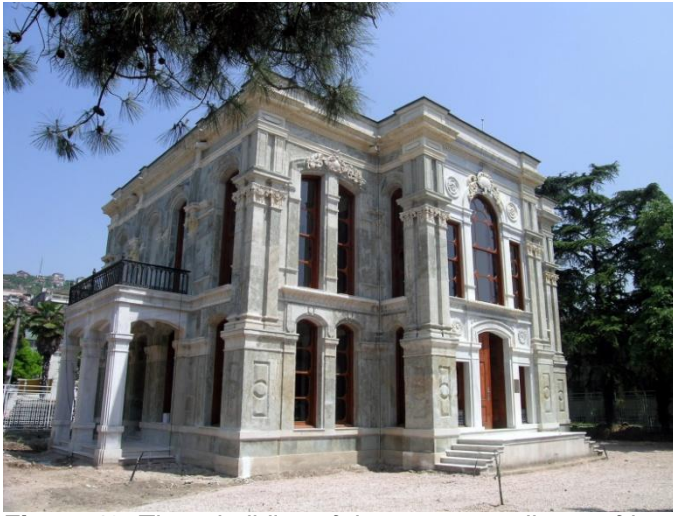
Figure 12. The rebuilding of the parapet wall at roof level with the re-use of the detached fragments.

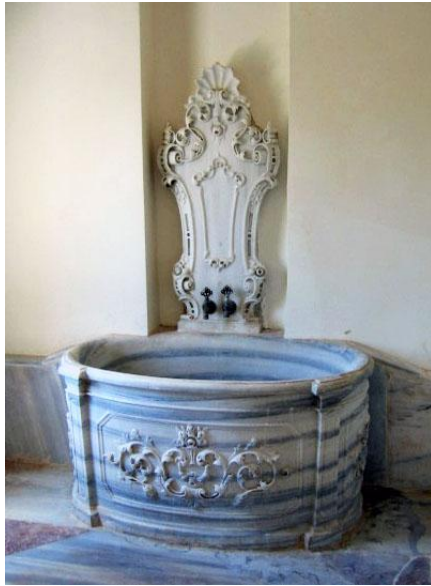
Figure 13. The marble staircases, balustrades, window frames, floor claddings and sanitary installations were cleaned with appropriate methods in accordance with the results of the analyses of their surfaces, depending on the types of dirt and staining.

The pollution particulates and black gypsum crusts deposited on the walls were cleaned with a series of implementations: following a dry mechanical cleaning, the free particulates were removed with short-term atomized water sprays whereas AB57 gels were used to remove the black gypsum crusts. The lower plants growing in the joints especially on the north façade due to problems of humidity and lack of maintenance were pruned by hand, and their roots were dried with herbicides. The sanitary equipment in the wet spaces, the marble floor claddings and the marble steps of the staircase were cleaned according to the methodology proposed in the material analysis report. (Figure 13)

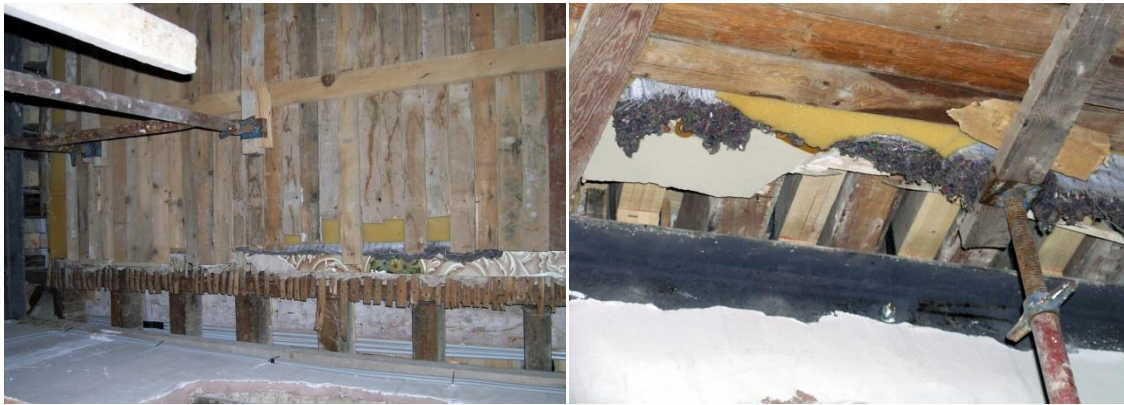
In the large hall where the span is very wide and the floor trembled when somebody walked on it, it was observed that the tips of the beams were damaged and the timber sections were not adequate. This floor system was structurally strengthened with the addition of new laminated timber beams between the original ones; these were supported with L-shaped steel profiles hung upside down on the walls. (Figure 14)

Figure 14. The condition of the intermediate floor structure between the two levels and the transfer of the loads to the load bearing walls from the additional timber beams.

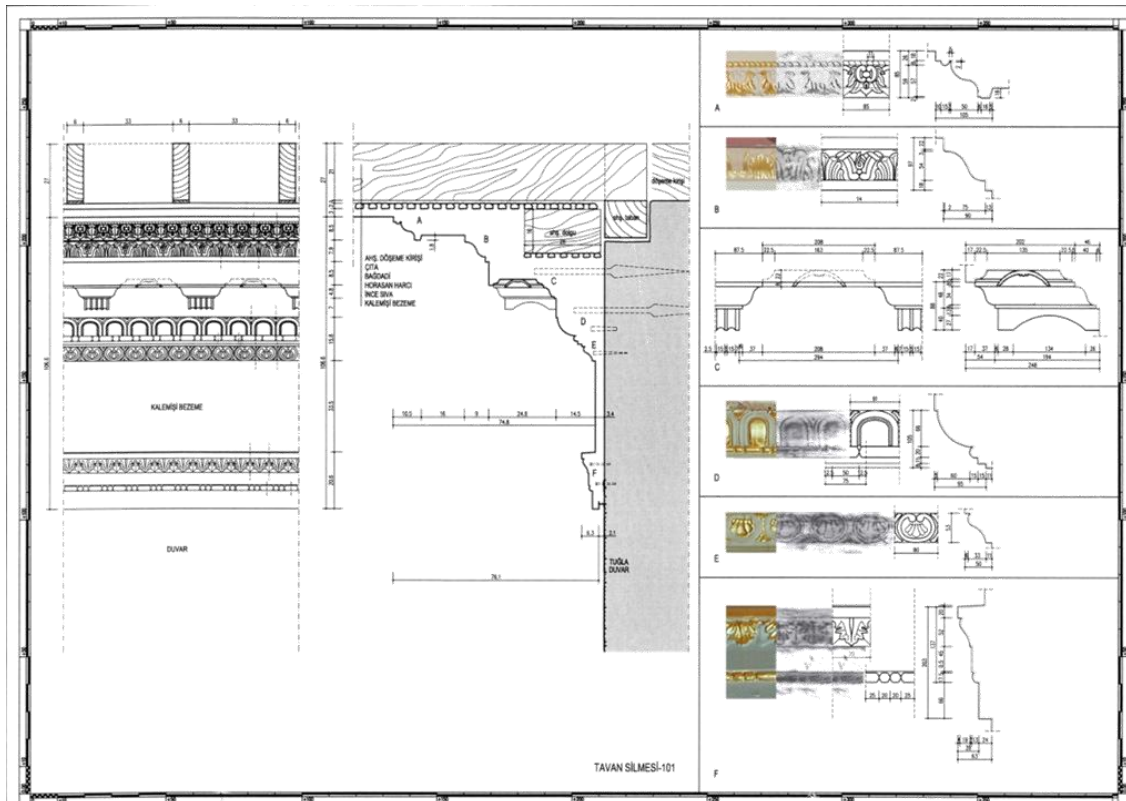
The deterioration of the timber floor beams and the wood lathing on the ceilings led to great damage on the plaster and paint decorations especially at the upper floor level. The ceilings at the ground floor level were in better condition. Following the photogrammetric and photographic surveys and colour analysis, a grid system was formulated and numbered on the drawings showing the remaining parts of the ceilings. (Figures 15-16) Then

Figure 15. The mouldings at wall-ceiling joints were surveyed and documented in detail at 1:10, 1:5 and 1:2 scales and tracings were made of their decorative elements.

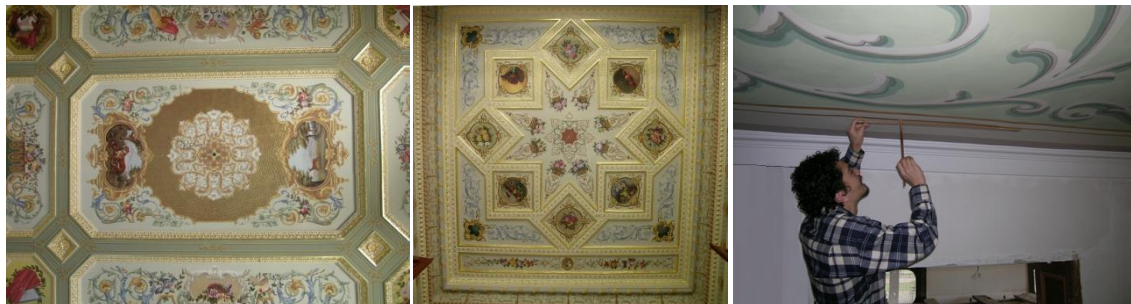
Figure 17. The decorative programme and ceiling paintings were repaired and re-painted based on the fragments remaining in-situ or detached and collected from the floor and a detailed survey and documentation of all material.

the ceilings were dismantled according to this grid system and the plasters were consolidated in situ. The timber floor system, which had become structurally unstable was also dismantled and rebuilt using timber beams in original size and form. The wood laths were replaced with new material as well. Plaster, gypsum finishing render and a primer was re-applied on the new ceilings. Based on the detailed documentation carried out before the earthquake, the decorations (*kalemişi*) were re-painted in original colours on these surfaces following the application of the geometrical axes and dusting for the patterns. The dismantled and consolidated parts of the decorative programme such as flower bouquets, coats of arms and painting panels were attached to the wood lathing with screws. The joints between these original parts and the new application were closed and finished with careful workmanship during the plastering phase. (Figure 17)

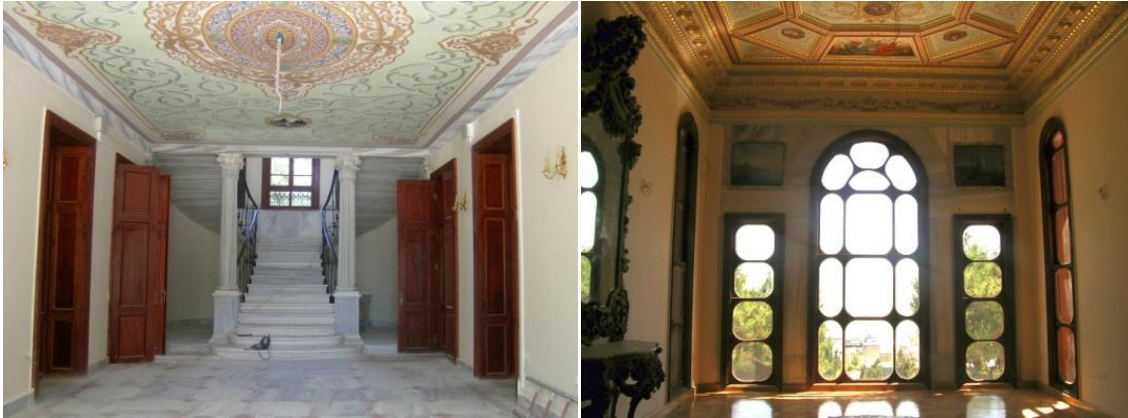
Figure 18. The view of the interior spaces following the renovation of the wall and ceiling surfaces and decoration.

The masonry superstructure of the smaller rooms along the north façade had been formerly repaired and altered as well. Later uncharacteristic additions in these areas were defined through probing and dismantled, and the survey and documentation project was revised according to the recently revealed data in these areas while the general building and damage assessment was reviewed. The original plasters where they had been preserved were consolidated with an acrylic resin emulsion but those areas which were previously repaired with Portland cement plasters were mechanically cleaned and re-plastered with a lime mixture similar to the original according to material analysis. (Figure 18)
