Structural evaluation of traditional masonry buildings during the February 6 - 12, 2017 Ayvacık (Çanakkale) earthquakes in Turkey

Caner Göçer

gocercan@itu.edu.tr • Department of Architecture, Faculty of Architecture, Istanbul Technical University, Istanbul, Turkey

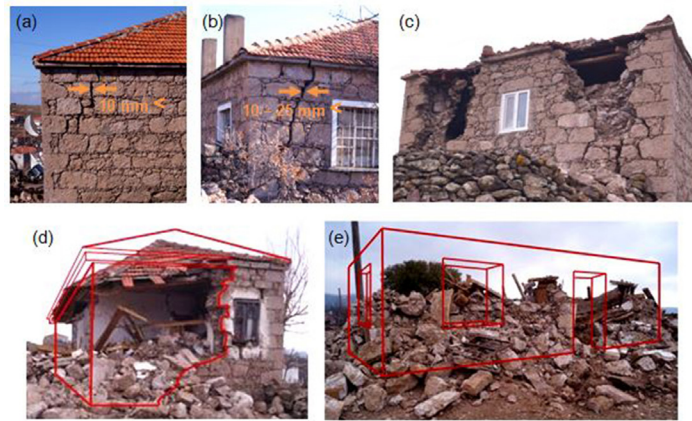
In Yukarıköy, it was determined that the earthquake damaged seventy-two structures in different degrees of impact. The damage was classified in five categories: slight, moderate, heavy, partial collapse and complete collapse. It was observed that the external walls of the slightly damaged houses had one-directional cracks of a width of less than 10 mm. When the forces of the earthquake hitting the structure were parallel to the wall, the cracks were seen to be slanted; when they had a perpendicular impact, the cracks were horizontal and vertical (Figure 5a). The external walls of moderately damaged houses had cracks in the shapes of X's that measured 10-25 mm (Figure 5b). Some parts of stone walls that were forced to bend out of plane showed signs of delamination and partial collapse. Large cracks of more than 25 mm were observed in the load-bearing internal and external walls, in the body of the walls and at the wall connections of the heavily damaged houses. In addition, it was also determined that the joining points of these load-bearing walls displayed vertical ruptures, divergences from the vertical and partial collapse (Figure 5c). In partially collapsed houses, it was seen that the load-bearing external walls had been partially wrecked or wrecked along the length of the plane and that because of this, the roof or intermediate floor structure had also partially caved in at these regions (Figure 5d). It was determined that totally demolished houses exhibited ruptures at the corner joints of their load-bearing external walls or had been fragmented in the middle of the structure (Figure 5e).

Figure 5. Building examples of the masonry structure according to the degree of damage: slightly damaged (a), moderately damaged (b), heavily damaged (c), partially collapsed (d), and completely collapsed (e).

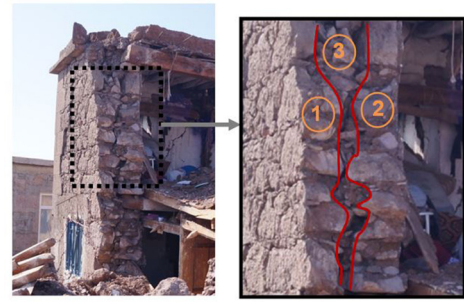
The rural houses in Yukarıköy were subjected to horizontal earthquake forces from different directions and depending upon their specific structural characteristics, suffered different types and degrees of damage. The lesser durability of the bonding mortar used in masonry systems compared to stone blocks plays a role in the behavior of collapse. Figure 6 shows a section of a partially collapsed load-bearing external wall, where the cracks, disintegration and the wall building system that ultimately caused the wreckage can be seen. The reasons for such types of damage lie in the rubble stone form of the stone blocks and their irregular sizes, the irregularities in the building system, and the unsuitability of the mortar that has been used to bond the rubble stones together. Also, the spaces in-between the rubble stone blocks have been filled in with pebbles and earth, a practice that increases the irregularity of the wall-building system. These small particles of stone have no bonding response and very easily separate from the wall as the result of a vibration, leaving spaces between the larger stones. As can be seen in the closeup of the section of the wall in Figure 6, the mud mortar in section 2 has cracked from the impact of the earthquake and has resulted in a vertical cavity in the midsection. Because of the lack of a tie beam, the partial divergence, disintegration caused by ruptures in the external wall has separated

on a vertical plane into three separate zones. Another important reason for the occurrence of this type of damage was the failure to position the rectangular binding stones at regular vertical intervals on the horizontal plane and along the width of the wall. The spaces formed here constitute the first steps in the occurrence of damage that gradually progresses to the collapse of load-bearing walls. In Figure 7a can be seen the partial rupture and flaking of the load-bearing external wall of a structure that has sustained such damage. The lack of a tie beam at the level of the roof on the external wall is also a major cause for rupture and disintegration. It was observed that the impact of the earthquake also caused the interior spaces of the Yukarıköy houses to sustain heavy damage in the form of partial collapse of fireplace and chimney extensions (Figure 7b). In some buildings, chimneys completely collapsed and in others, deformations occurred. There were partial fractures in the upper sections of the external walls in the parts of the fireplace leading up to the chimney. The reasons for this were the irregular bonding systems used in the region, thinning walls and the drying with time of the mud mortar bonding the stone blocks due to extreme heat emitted from the fireplace. In some structures, wooden lintels were used in the upper parts of the load-bearing walls. Because of the thinness of these wooden lintels and the shortness of the section sitting on the walls, the forces of the earthquake running parallel to the walls caused cracks and partial collapse. This type of damage can be seen in Figure 7c. Using larger sizes of stone materials to maintain the continuity and rigidity of the load-bearing walls would have been a more appropriate solution.

Figure 6. Size of the stones on the body of the external wall and ruptures in the building system.

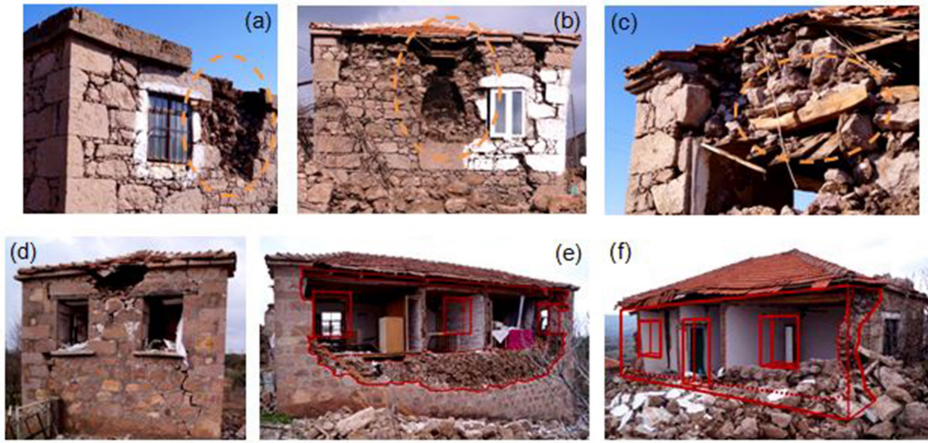
is from here that shear cracks start to appear. These cracks are generally on a diagonal. One of the walls intersecting the diagonal and vertical cracks sustained an impact along the plane and the other perpendicular to the plane. When the vertical crack deepens and fracturing occurs, the connection between the walls falls apart and the independent pieces resulting from the diagonal cracks slide and tumble down due to the horizontal load and the effect of gravity. This type of damage can be seen in Figure 7d.

External walls can become unbalanced due to the disintegration of the bond between the internal and external wall and may consequently fall into an out-of-plane collapse. These types of damage can be seen in the corners of many slender walls. In Figure 7e, the force of the load bearing down perpendicularly on the structure's external wall plane has caused both vertical and diagonal cracks in sections of the lower part of the wall near the joining points and then, a collapse of the wall due to the continuation of tremors. The prevention of this type of damage requires first of all that internal walls are of adequate thickness, that the size of the stone blocks are big enough and of the right formation to ensure rigidity at the joints, that the mud mortar used for bonding is of adequate durability, and that there is a continuity of tie beams at the lower and upper parts of load-bearing walls where they are joined together. Out-of-plane collapse could have been prevented if large binding stones had been positioned at vertical regular intervals at the joinings between external and internal walls. The internal wall structures of the houses of Yukarıköy

Figure 7. General damages of body of the external walls: partial collapse and disintegration (a,b,c), diagonal shear crack (d), and out-of-plane collapse (e, f).

were built from stone, fired clay brick, cement-based briquette blocks and wood. There was no serious damage in the internal walls of these types of buildings. On the other hand, in some buildings, the external walls separated from the internal walls along the plane and collapsed because of the lack of a bonding system that ensured the adequate clamping of internal and external walls (Figure 7f).

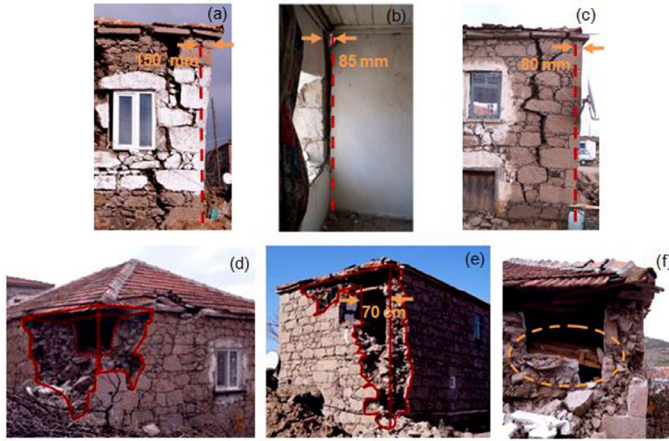
It was observed that some structures in Yukarıköy suffered partial collapse of external walls in the form of pieces that collapse in an upward direction where two walls joined. Figure 8d displays this type of partial collapse. It was seen that this type of damage did not occur in corners sustaining the load impact of the earthquake where large, rectangular stone blocks had been properly bonded together. When window openings are close to corners where walls are joined, the in-plane rigidity of load-bearing walls is reduced. Figure 8e shows a structure where partial collapse has occurred from the impact of the earthquake in the corners where the external walls were joined. Figures 8a, 8c, 8d, 8e and 8f show general damages that were caused by the weak binding at corners. The failure to place binding stones as part of an orderly bonding system at the corner joinings is the main reason for these types of damages. The connections of the roof structure with the load-bearing wall are one of the important factors that impact the earthquake performance of buildings of masonry. The rigidity (i.e. the diaphragm effect) of the floor and roof covering, their integrity and the manner in which they have been bonded to the load-bearing walls

Figure 8. Vertical displacement of load-bearing external walls (a, b, c) and partial collapse in corner sections (d, e, f).

are important elements in preventing walls from separating from each other and disintegrating and in ensuring that the roof does not collapse. If the wooden roof and floor structures had diagonal binding components, neither the roof structure nor the loadbearing wall would have collapsed. In Figure 8f can be seen the damage sustained when ceiling beams of wood directly transfer their load to the load-bearing walls. Here, the lack of connecting beams at the upper sections of the external and internal load-bearing walls, the fact that the wooden beams have been kept shorter than required, the weak connection or the lack of rigidity in the supporting wall are some of the reasons the timber ceiling beams have slipped away from their supports (i.e. unseating) and have partially collapsed. In two-story houses or those where the ground floor level has been elevated, the floor system cannot maintain its rigidity because the floor beams in the intermediate floor systems cannot transfer their load to the walls by means of a tie beam. As a result, the floor construction and the ceiling covering become deformed.

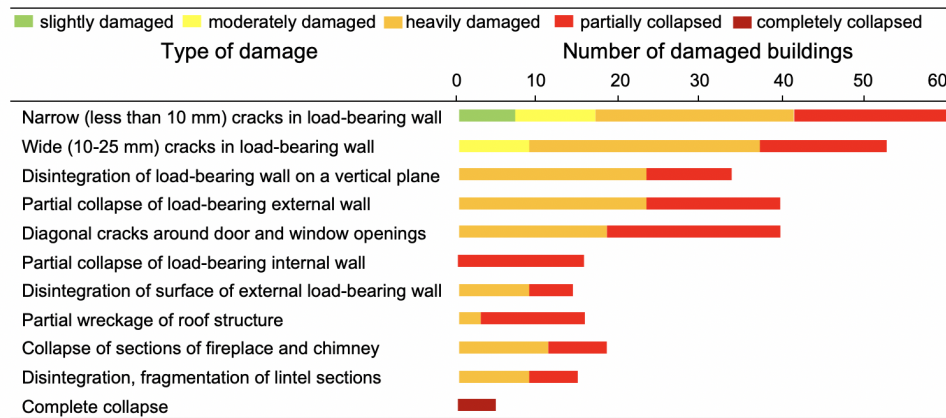
Table 1. Types of damage caused by the Ayvacık earthquake and distribution of degrees of damage.

quakes. Table 1 displays quantitative data on the general types of damage and the distribution of these types of damage according to the degree of damage resulting from this earthquakes.
