# An investigation of the conservation problems of volcanic tuffs used in the facades of Dolmabahçe Palace

In this article, the stones used in the facades of the Dolmabahçe Palace and the environmental factors surrounding the palace are investigated. In particular, the protection problems of the volcanic tuff stones are investigated. And by the experimental studies, conservation proposals were obtained. This article is thought to be helpful for future facade preservation work.

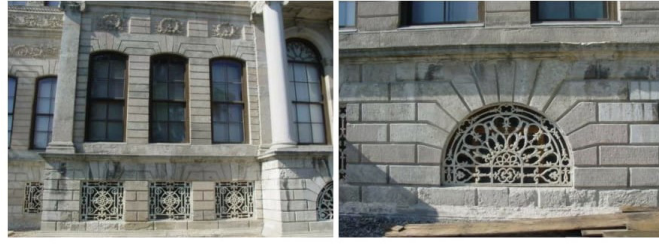
**Figure 3.** Tuffs used in the external facades of Dolmabahçe Palace.

Karamürsel Od stone is mentioned to have been quarried from the quarries in Dereköy /Tepeköy, in Karamürsel-Kocaeli province in various sources. The quarries of the Şirincavuş volcanic tuffs are located on a slope overlooking the southern shore of the Marmara Sea, and the former name of the village was indeed Şirincavuş. These tuffs were removed and used in various historic periods (Romans, Byzantines and Ottomans). These young volcanics, which are in the form of trachitic tuffs, which are in large outcrops in the north-western part of Şirincavuş village, are generally gray, pink, coffee and sourcherry, Figure 3.

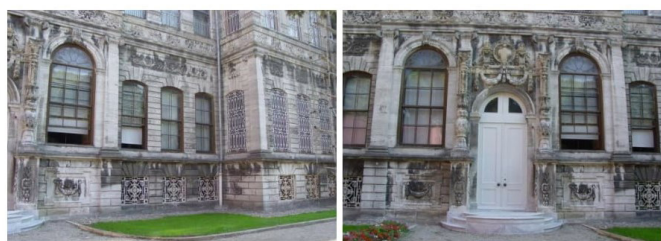
**Figure 4.** Pollution effects on palace's facades.

reason, chemical degradation occurs in the form of quartz, feldspar and iron-magnesium minerals. The most typical alteration morphology is the brown staining of the feldspar on clay surfaces, shown in Figure 6. These stains are formed in the weakest parts of the stone and sometimes start from the surface to the inner parts of the stone until it is determined to cause fragmentation, Figure 4.

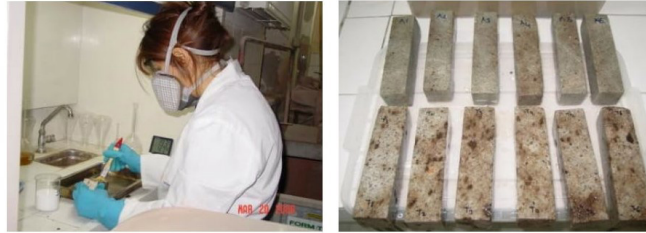
**Figure 8.** Application of chemicals in laboratory conditions.

The Wacker SMK 1311 emulsion was diluted with water at a ratio of 1:10 and was applied to the surfaces by brush. The implementation time was 40 minutes, and 8 cycles were applied at equal intervals until the saturation level, Figure 8. The depth of the water repellents used was 2-3 mm. The samples were kept under constant ambient conditions for 4 weeks because of the polymerization time and then the experiments were initiated.

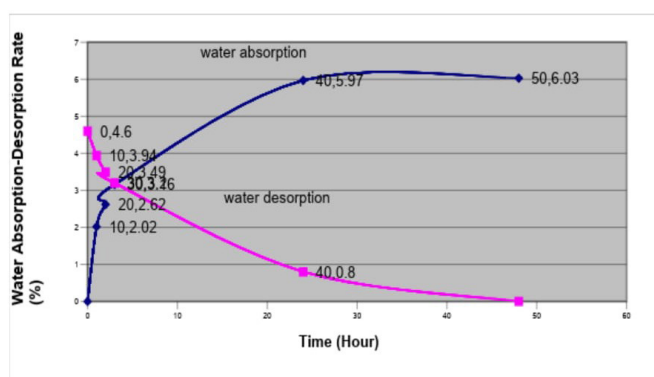
Figure 9. The graph of water absorption-desorption rate of untreated samples.

In the table above, it was seen that the decrease in capillary water absorption ratio and the ratio of water absorption in atmospheric pressure was found 88% and 70% respectively. As these results are seen promising, the further studies were continued (Figure 9-10, Table 3).

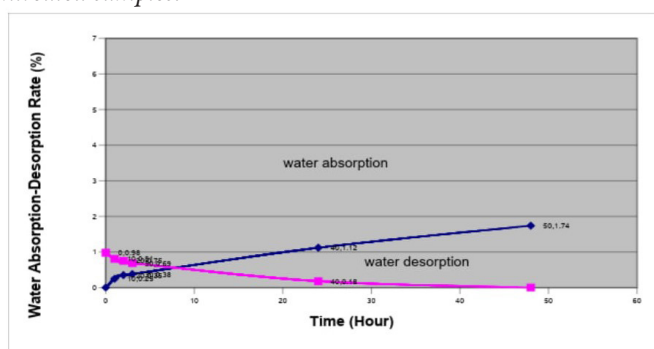
Figure 10. The graph of water absorption-desorption rate of treated samples.

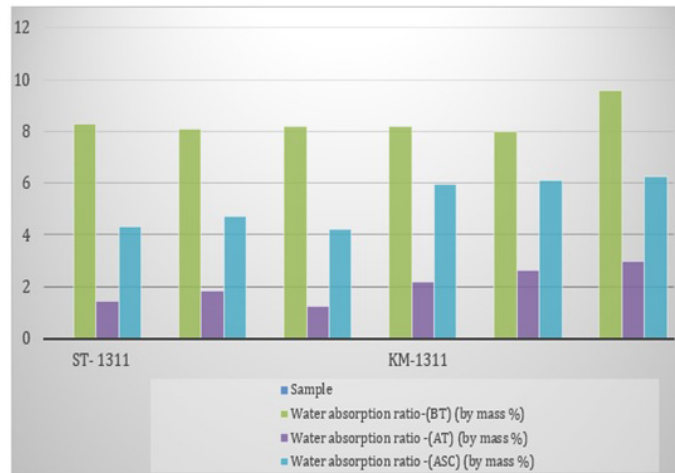
**Figure 11.** Changes in Water Absorption by Mass Ratio Values of ST and KT stone samples.

ST: Şirince tuff, KM: Karamursel tuff

BT : Before chemical treatment / AT: After chemical treatment / ASC: After Salt resistance

During the salt crystallisation test, the changes in physical appearance of the samples were observed day by day. At the end of the test, physical and mechanical property tests were repeated in order to determine the long term performance of treatment. Untreated samples absorbed much more salty water (behave like acidic agent) than the treated samples. Repeating the cycles consisted of immersion of salt solution and drying in oven made the samples damaged in different levels. The mass of untreated samples were increased first, then the mass is decreased critically. The brown zones were seen increasing then these zones turned in to empty holes. Empty holes were enlarged and then the untreated samples were broken into pieces. And moreover an evident change in the color of untreated samples were observed. In the other case, as absorbing less salty water, the brown zones were not enlarged in treated samples. At the end of the durability test, a minimal change in the mass of the treated samples was detected. And also, the change of water repellency performance was measured as acceptable degree. The results were preferred to be shown in bar chart graphs in order to present the property change, shown in Figure 11-12.

As seen in the figures, treated samples were not so much affected from the salt resistance test. The water absorption ratios of the treated samples were only approx. 30% increased. This means the treatment with the water repellent chemicals was found successful.

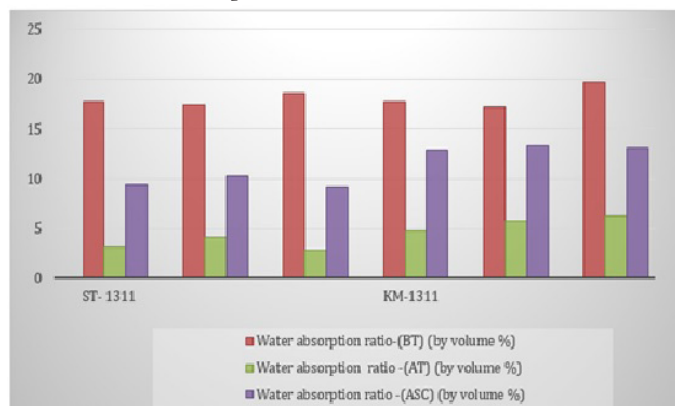
**Figure 12.** Changes in Water Absorption by Volume Ratio Values of ST and KT stone samples.
