# Retrofitting project evaluated in regard to architectural usability of buildings

**Tuğçe KAZANASMAZ**

*Izmir Institute of Technology, Faculty of Architecture, IzmirTURKEY*

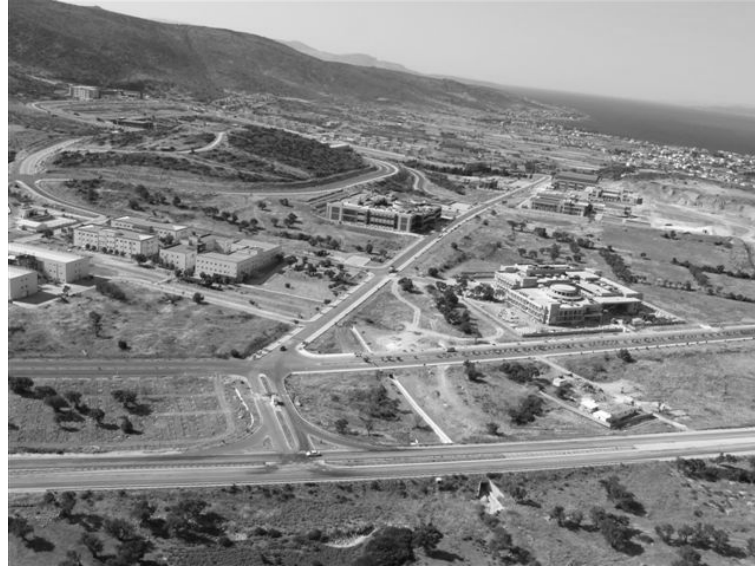
**Figure 1** General view of İYTE Campus, İzmir (Source: Photo Gallery of İYTE; <http://www.iyte.edu.tr/>)

Buildings belonging to the Faculty of Architecture are situated in the northern part of the campus on a hilly site as shown in Figure 1. Office and studios are located both in a 4-story building (Block A) and in a 3-story building (Block B). While Block A is 4800 m<sup>2</sup>, Block B is 4897 m<sup>2</sup> in total, as the schematical expression of the basic layout is shown in Figure 2. The story height for all floors is 4.00 m. There are a total of 80 rooms in Block A, and 42 rooms in Block B with various accommodation and layout. Each floor contains 8
