Conservation of the Khakhuli Monastery: An architectural overview and future scenarios

Mustafa Tahir OCAK^{1*}, Gülsün TANYELİ²

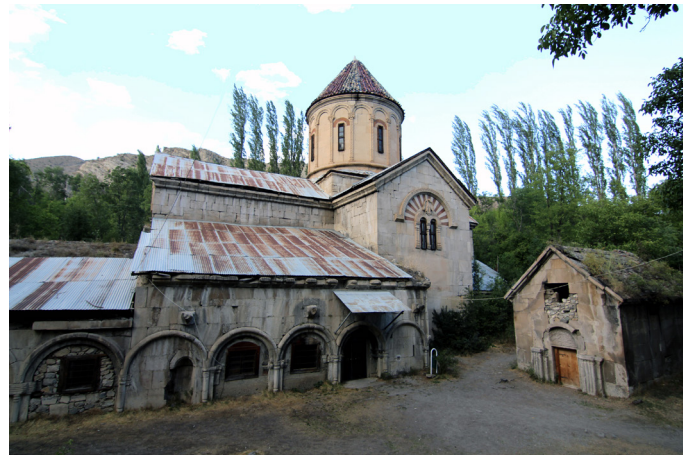
Figure 1. The south façade of the monastic church and the south chapel (photograph by the authors, 2021).

The main entrance of the domed cruciform church is located on the south side. Both the main wall and the south façade of the entrance hall are rich in bas-reliefs and figures of animals. The eastern arm of the structure consists of apsed pastophories and a wide apse positioned 73 cm above floor level, accessible by steps. There is a niche in the middle of the apse, and on both sides of this niche, there are four equal arched niches with heights of 5.50 m. Djobadze (1992) noted that the niche in the middle could have held a bishop's throne. The annexes were entered from the cross arm of the church in the original plan. Today, however, the annexes can be entered only through destroyed sections of the wall and their

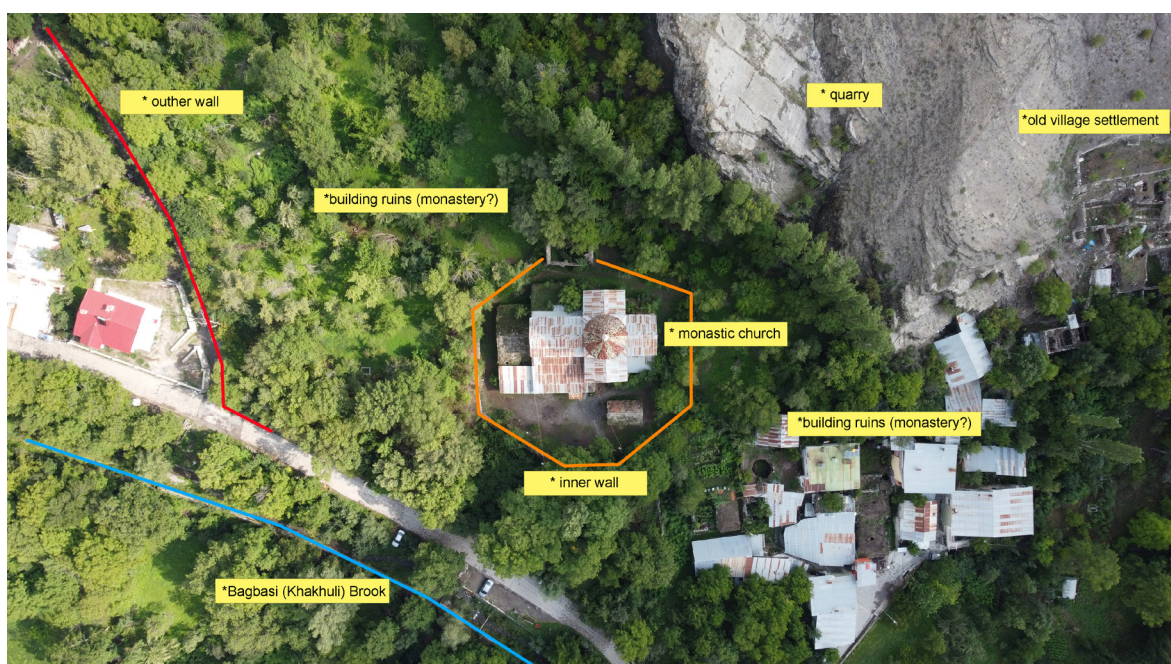
Figure 3. Drone photograph showing Khakhuli Monastery and its surroundings (photograph by the authors, 2021).

are located within inner walls that enclose an area of 2242 m². This area, surrounded by a wall approximately 3 m tall, is entered via an arched opening in the south. The ruined bell tower is accessed by stairs adjacent to the entrance gate (Takaishvili, 1952). Eighty meters west of the monastic church, there is an outer wall that is thicker than the inner wall, extending on the north-south axis. As this outer wall approaches the Khakhuli (Bağbaşı) Creek, it turns towards the east and continues in parallel to the creek. Between the inner and outer walls, there are remains of buildings thought to have belonged to the monastery (Figure 3).

in the monastery buildings were obtained is located approximately 50 m northeast of the monastic church. The natural slope of the quarry is such that stones could be transported to the construction site quickly after being cut (Figure 3).

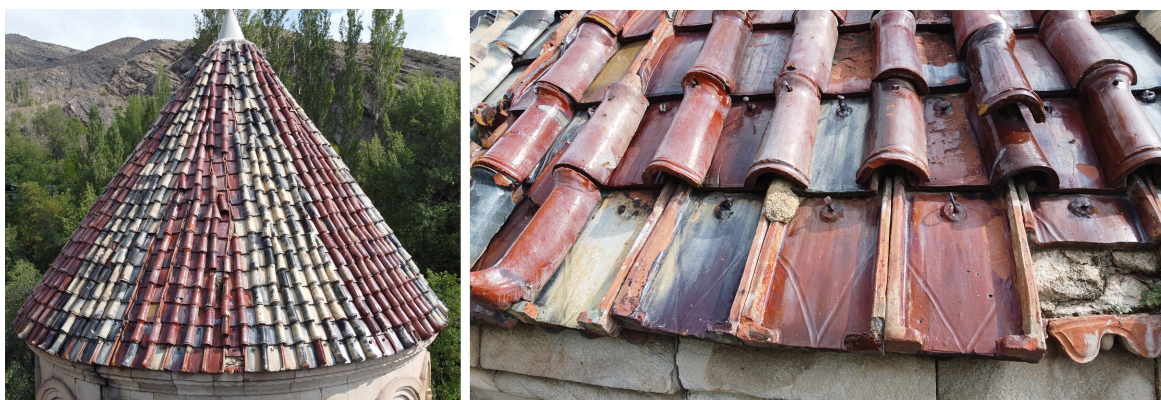
Figure 6. a) Dome cover of Khakhuli's monastic church; b) Detail of the tile cover of the dome (photographs by the authors, 2021).

Ceramic tiles were used for the roofing material of the dome and vaults. The first row of tiles was placed on the eaves of the vaults and the dome. For the eaves, rectangular tiles were arranged in rows. The first three rectangular tile rows were fixed with metal nails and the exposed edges of the tiles in those rectangular rows were covered with semi-cylindrical tiles (Figure 6).

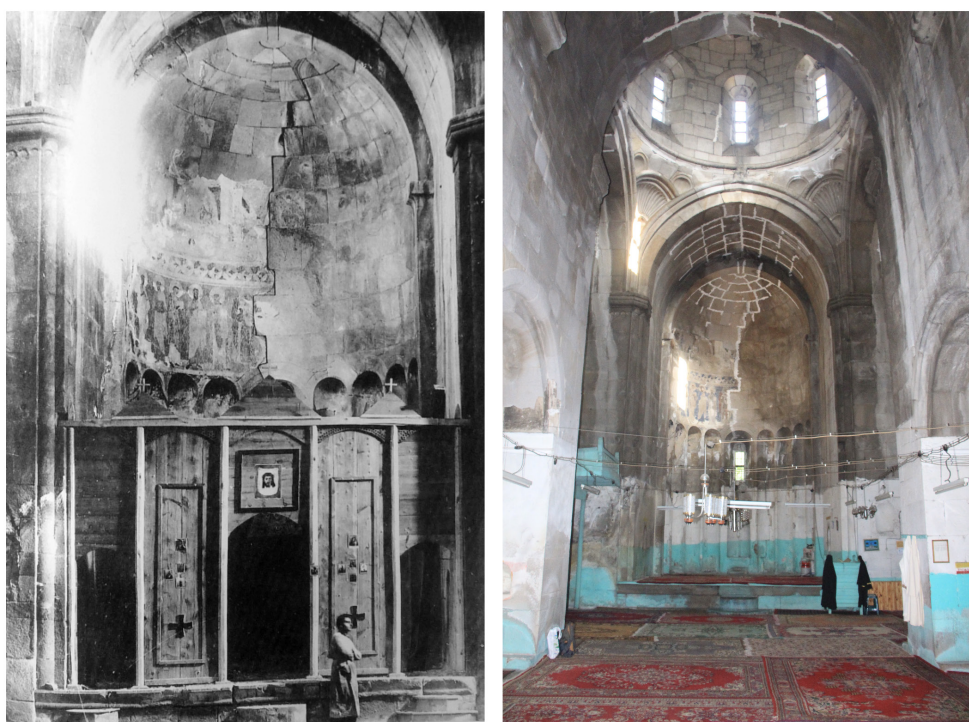
Figure 8. A wooden iconostasis was added to the church's apse in 1916 (Takaishvili, 1952); view from inside the church (photograph by the authors, 2021).

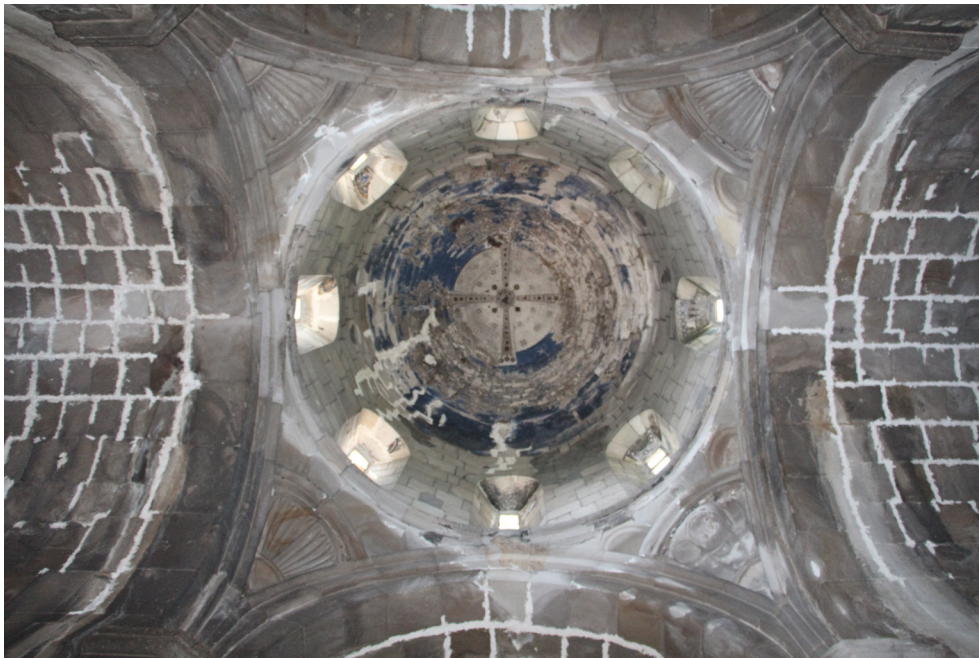
Figure 9. Dome of the Khakhuli monastic church (photograph by the authors, 2021).

Another structurally problematic part of the building is the dome: there are cracks on the inner and outer walls from the drum to the dome (Figure 9). The south annex is also structurally problematic. The fact that it has been repaired many times shows that its structural problems have existed since the early times of the church.
