The experimental works conducted on modern heritage and mixed system buildings with the purpose of the conservation and restoration

Seden Acun ÖZGÜNLER¹, Mehmet Serkan YATAĞAN², Nihal ARIOĞLU³

This study is about the conservation and restoration of the education buildings in Istanbul University which were constructed as the mixed structures of reinforced concrete framework and masonry in the 1940s, maintaining their original form and cultural heritage value.

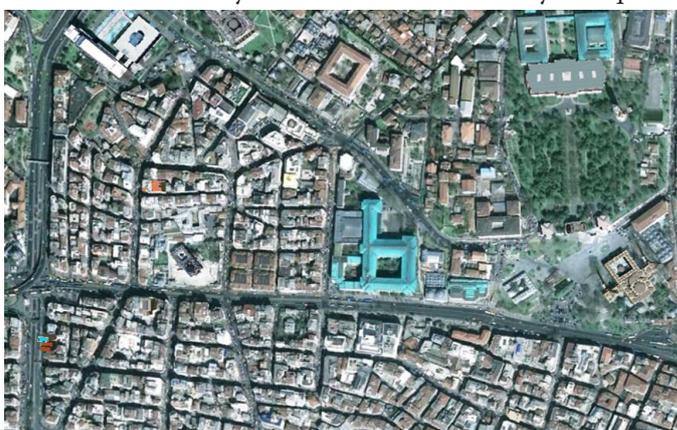
Figure 1. Aerial photo and layout plan of the examined structure.

The buildings of the Faculties of Science, Letters and Aquatic Sciences at Istanbul University were examined. These buildings are located in the historical peninsula of Istanbul, which is included in the UNESCO’s world heritage list, more specifically in plot 20-113, building block 2707, Balabanağa neighborhood in the district of Fatih, Istanbul (Ahunbay, 2004). The view of the structure from the southeast facade is given in Fig. 1. This structure has been registered as cultural heritage by Istanbul Heritage Board.

II Mosque to the east, Süleymaniye Mosque, Kuyucu Murad Paşa Social Complex and Kalenderhane Mosque, which was originally a church in the Byzantine period, to the north (Fig. 1).

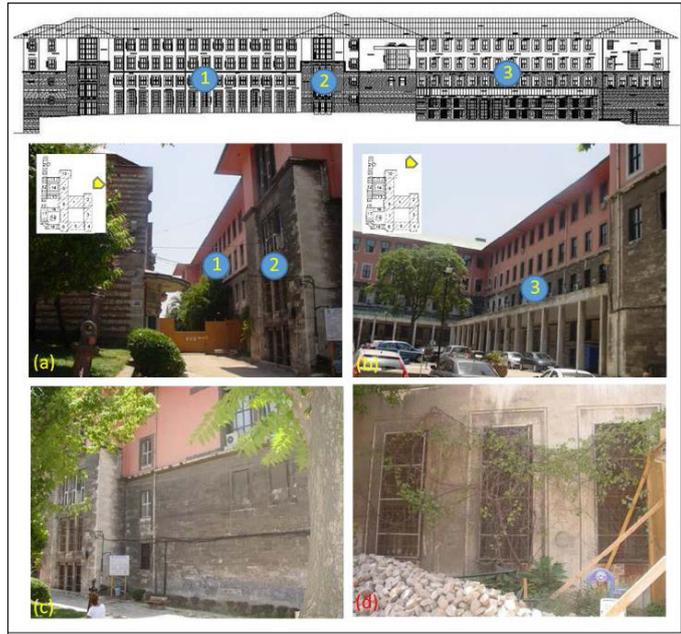
In situ examinations were conducted in order to detect and document the effects of environment and any other parameters on the building materials of the structures. Among all the factors, air pollution was seen the most affective factor on the surfaces of the materials. For example, surface contamination due to air pollution was observed on the eastern facade of the structure facing towards the Vezneciler Street and Kimyager Derviş Paşa dead-end Street (Fig. 2). The façades of the structure other than those that were

Figure 2. Eastern facade: (a) Faculty of Letters, (b) Faculty of Science (c, d) Contamination in facade and window jamb.

ing the top of the arcaded section and the inner parts of all window jambs were contaminated. Besides, the structures of the colored mortar between the jamb and the lintels became empty because of the surface abrasion.

As such, it was recommended to brush the black layers on the stone surfaces using water, non-ionic detergent or steam. For persistent stains, the use of soft aggregates, such as calcite or dolomitic smaller than 125 μ and micro sanding technique under low pressure (1-1.5 a), was recommended. In applying this technique, a small section of the facade should be tested to determine the appropriate pressure, and then, the technique should be applied to all surfaces. Cleaning applications should not be carried out in very cold or very hot conditions. Spring months are suitable to apply this technique attention should be paid to ensure that the stone surfaces to which water has been sprayed dry soon, as the water that remains on the surface for ex-

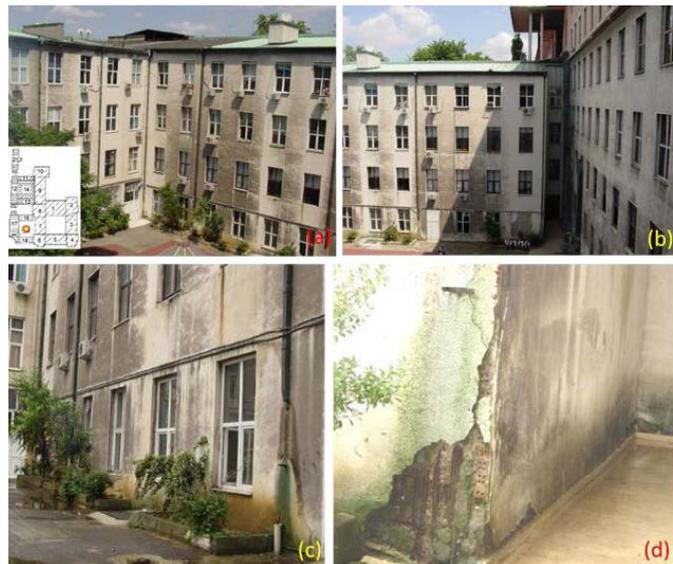
Figure 4. Faculty of Aquatic Sciences: (a, b) Inner court, (c) Facade contamination, (d) Corrosion effect in reinforcement.

While surface abrasion could be observed on the southern facade of the structure facing Ordu Street, extreme contamination was apparent on all-natural stones facing the inner courtyard at the Faculty of Letters. Contamination could be observed on the façades of the buildings facing the courtyard in the Faculty of Aquatic Sciences. Moreover, the load-bearing system elements of the buildings were damaged to a great extent (Fig. 4).

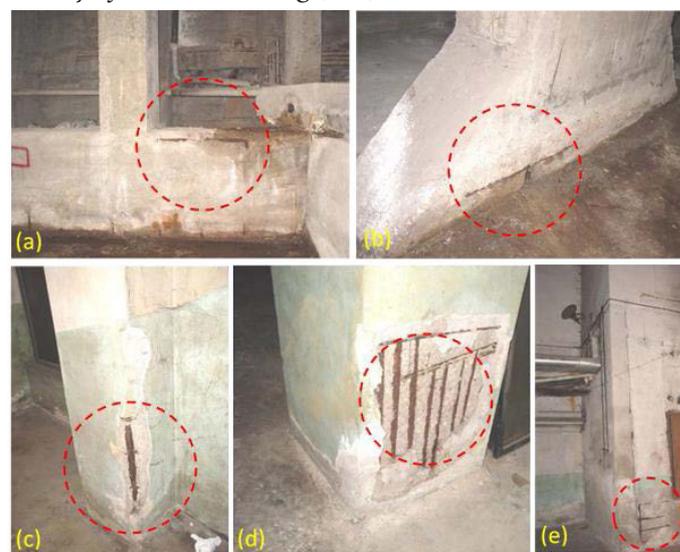
Figure 6. RC columns and foundations subject to corrosion effect in Faculty of Science building (a-e).

In the visual examination made on the buildings of the Faculty of Science and Faculty of Letters, the reinforcements had suffered from the loss of cross-sectional area due to corrosion. The linking water settled at the dilatation which was full of rubble between the binding beams and this situation deforms the structural system. (Figs. 5-7).

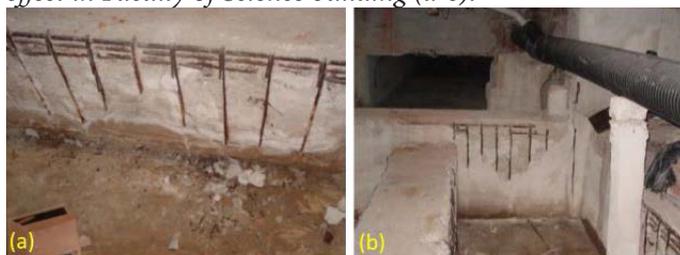
Figure 7. RC foundations subject to corrosion effect in Faculty of Letters (a, b).
