A critical look at the reuse options for a vernacular house in Alaçatı

Gamze SAYGI, Mine HAMAMCIOĞLU TURAN

Izmir Institute of Technology Faculty of Architecture Izmir TURKEY

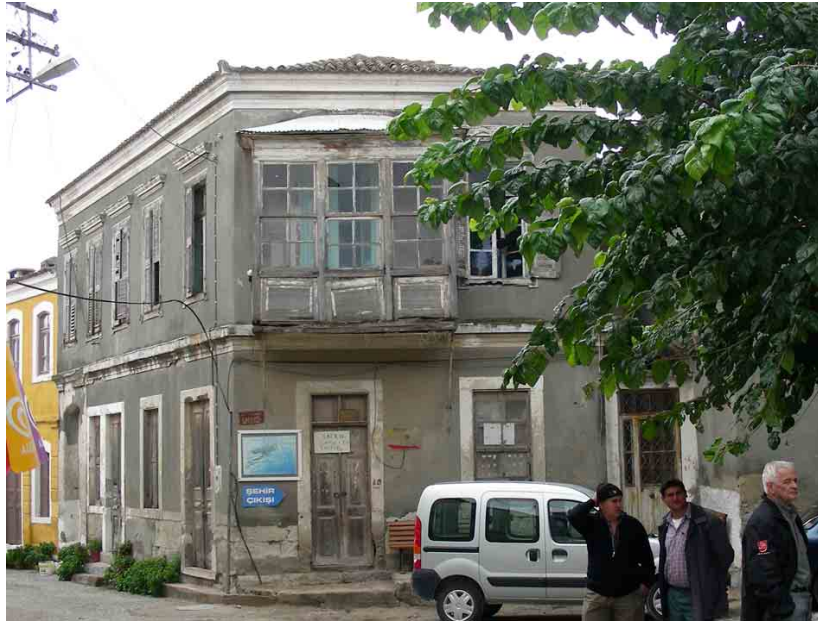
Figure 3. The Sezgin House viewed from the north (photograph is taken by authors; October 2006)

Sezgin House is a corner building with two stories and a rear courtyard. It is listed as a 2nd degree architectural heritage (Şahin, 2006). According to the inscription panel at the entrance door, the building dates back to 1891. There is not much information on its first Greek owners except the fact that they dealt with wine production (Interview with Hayriye Sezgin, 9 October 2006). The ancestors of the present users migrated from Kavala to Alaçatı in 1924.

The façades facing Mithatpaşa and Hacı Memiş Streets have preserved the design characteristics of the 19th century such as doors, windows with casings, wooden shutters, bay window and cornices. But, the courtyard façades of the Sezgin House have lost the original characteristics because of the interventions made by the inhabitants. The two houses neighboring the Sezgin House at its northwestern side contribute to the courtyard space with their original façade organization.

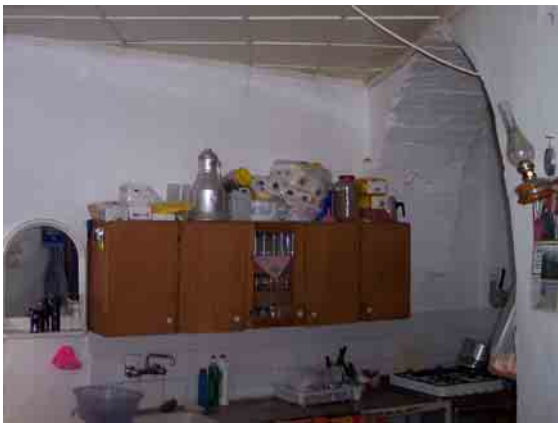
Figure 5. The kitchen on the ground floor and the stone arches, unit 2 (photograph is taken by authors; October 2006)

At present, the courtyard on the southwest of the Sezgin House is enriched with fruit trees and flowers, but there are unqualified wooden sheds added to the courtyard. The original wall fragment on the north of the courtyard is thought to belong to the stable of the house. Unit One (~68m²) has an entrance hall with an additional staircase, a toilet under the staircase and a storage space (originally a shop) at the northwest of the hall on the ground floor. Unit Two (~76m²) has an entrance hall with the original staircase, a toilet addition under the staircase and a room (originally a storage) juxtaposing the entrance hall, and a large kitchen (originally a wine workshop) (Figure 5). It is difficult to follow a definite order in the layout of the ground floor at present (Figure 6), but the idea of organizing rooms around a linear hall is still legible (Figure 7) (Murtezaoğlu, et. al., 2007). On the first floor of Unit One (~68m²), there is a small hall surrounded by rooms at all three sides (Figure 8). The main room used as a living room today has the bay-window on its north. The room juxtaposing the main room on its southwest leads to the additional mass, which is used as kitchen and bathroom. The small bedroom, which was originally a storage space ("sandık odası"), juxtaposes the main room at its southeast (Figure 9). In Unit Two (~96m²), there is a linear hall reached by the staircase. An L shaped living room on the east and two rectangular rooms at the west are connected to this hall. Through a door on the southeastern wall of the hall, one can reach to the original terrace space, which is converted to closed space at present. An L shaped hall, a room and storage space are present here. The L shaped hall leads to an additional mass on the west. Here, there is a bathroom and a terrace. The organizations of the plans are axial on both floors, but they are perpendicular to each other.

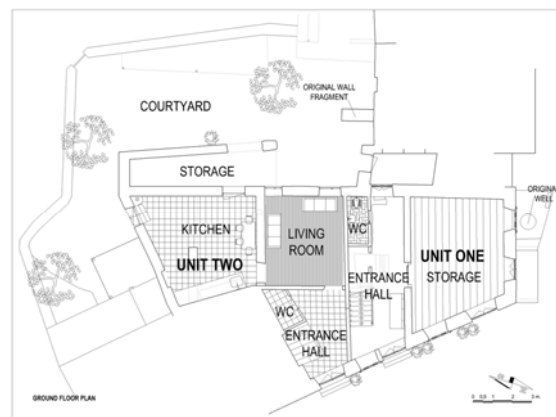
Figure 6. Ground floor plan: present usage scheme

The problems stemming from unqualified architectural alterations made by the inhabitants are as follows: The conversion of the original terrace to closed space and the mass additions at the courtyard side have caused lack of order in mass design. Unqualified workmanship of the additional masses and the altered door and window joints are also eye-catching. The division of the house vertically into two has changed the original spatial layout and the

circulation scheme. The staircase addition in Unit One and wet space additions in both units have become necessary because of the creation of two individual residential units.

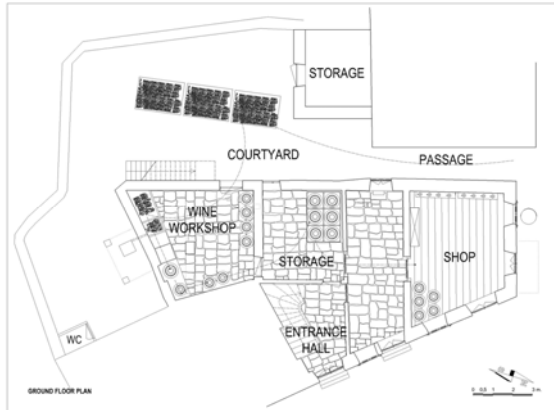
Figure 7. Ground floor plan: restitution scheme

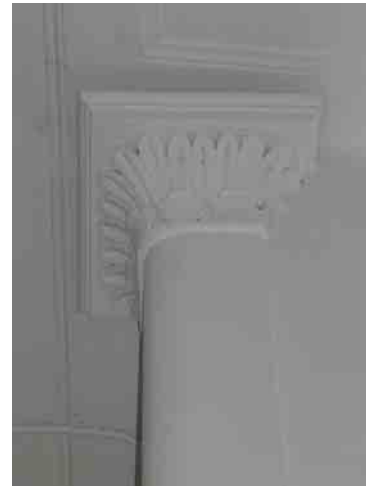
Figure 10. The plaster at the hall, unit 2 (photograph is taken by authors; October 2006)

The construction system and materials used in the Sezgin House repeat the common characteristics of the vernacular Alaçatı houses. The masonry walls with local tuff stones joined with mortar and reinforced with timber bonds at various levels are observed especially at the exterior walls. The majority of the interior walls and the bay window are in timber skeleton system. The walls are covered with plaster on both the exterior and interior. The exterior ones are gray or white washed, where as the interior ones are blue or green washed. Wood plank and beam system is preferred in the roof structure, the first floor and the floors of the storage spaces on the ground level. The ceilings of the main room and the hall in Unit One are enriched with paintings of leave and flower motifs applied on plastering over the wood planks (Figure 10).

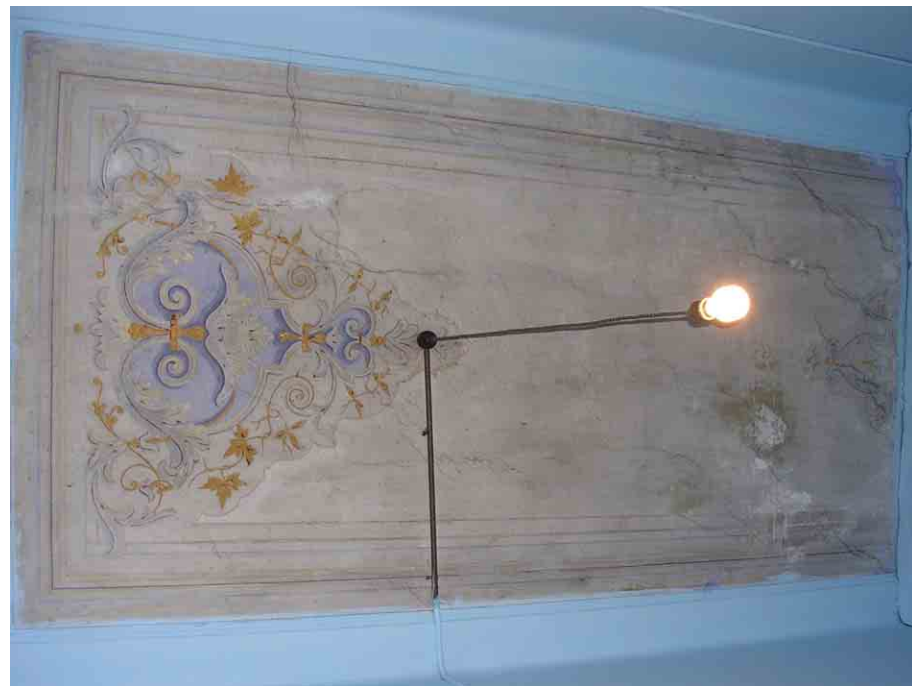
Figure 11. *Original ceiling painting at the first floor hall, unit 1*

- Part of a vernacular environment still maintaining its local qualities: it faces the Hacı Memiş Square.
- Continuation of the residential function.
- Continuation of the concept of privacy considered in the original design, despite alterations. Closed-open space relations, building-street-neighborhood relations, distribution of functions with respect to levels all indicate this consideration.
- Peculiar plan scheme with perpendicular axes on two floors; relatively large courtyard; original architectural elements such as corner ornamentation, bay window, casings, shutters; ceiling paintings, plaster (Figure 11), shelves, niches, fireplace; original building material.
