Izmit Sultan Abdülaziz Imperial Hunting Lodge: Restoration following the 1999 earthquake

Yegan KAHYA*

Abstract:

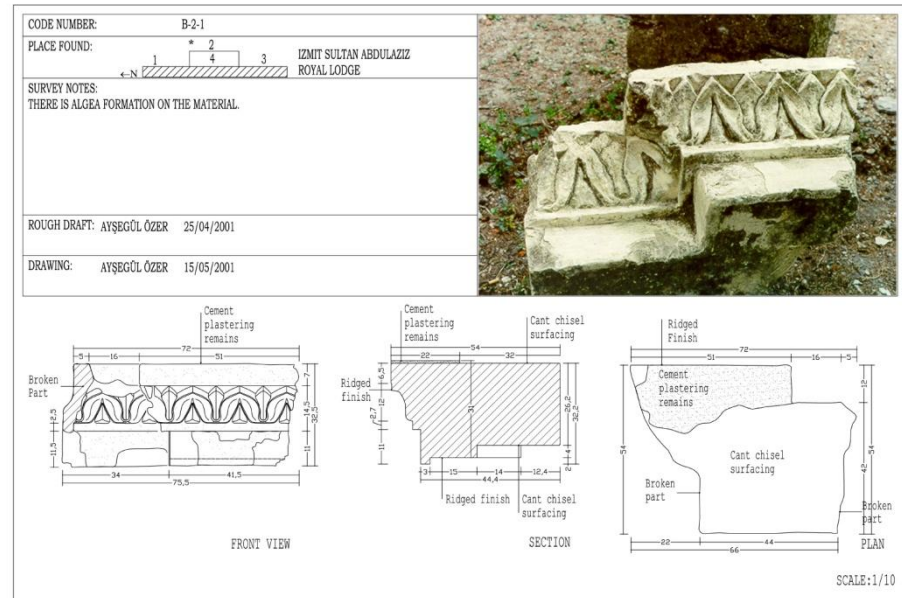
Figure 10. An inventory fiche was prepared for each fragment at 1:10 scale, documenting size, form, material and architectural characteristics and condition.

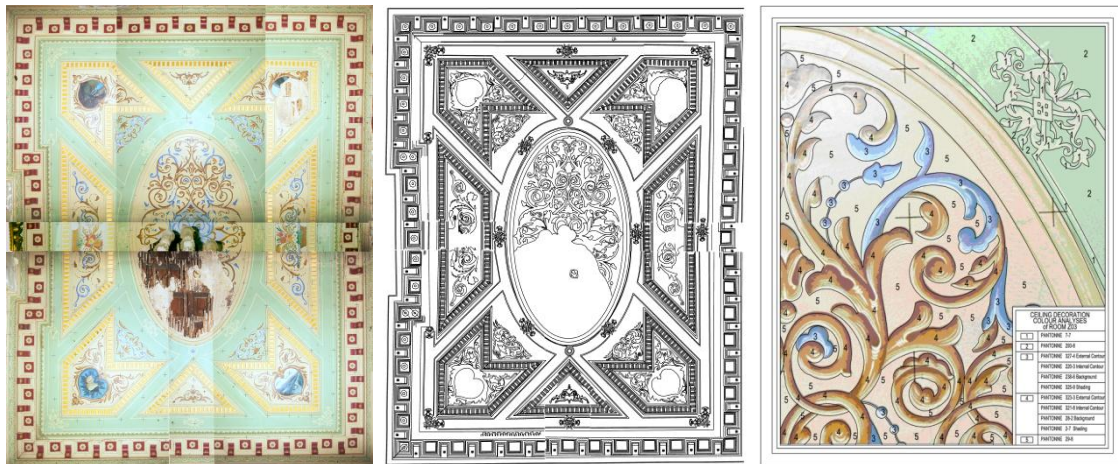
Figure 16. Rectified photogrammetric image of a ceiling, its architectural drawing and colour analysis.

the ceilings were dismantled according to this grid system and the plasters were consolidated in situ. The timber floor system, which had become structurally unstable was also dismantled and rebuilt using timber beams in original size and form. The wood laths were replaced with new material as well. Plaster, gypsum finishing render and a primer was re-applied on the new ceilings. Based on the detailed documentation carried out before the earthquake, the decorations (*kalemişi*) were re-painted in original colours on these surfaces following the application of the geometrical axes and dusting for the patterns. The dismantled and consolidated parts of the decorative programme such as flower bouquets, coats of arms and painting panels were attached to the wood lathing with screws. The joints between these original parts and the new application were closed and finished with careful workmanship during the plastering phase. (Figure 17)

The intermediate floor level was structurally strengthened from above, thus consolidating the lower floor ceiling plasters as well. The preserved ceiling paintings in the lower floor rooms were retouched in original colours paying close attention to Baroque forms and shading. The parts that have been fragmented and lost were re-painted making use of repetitive bordures and motifs according to the colour analysis. Heavy mouldings completely filled with plaster were located at the joints of these plastered ceilings with the walls during former repairs. These were replaced with lighter mouldings applied on wood-lath profiles and empty in section, thus correcting a repair design mistake, which caused increased damage during earthquakes.

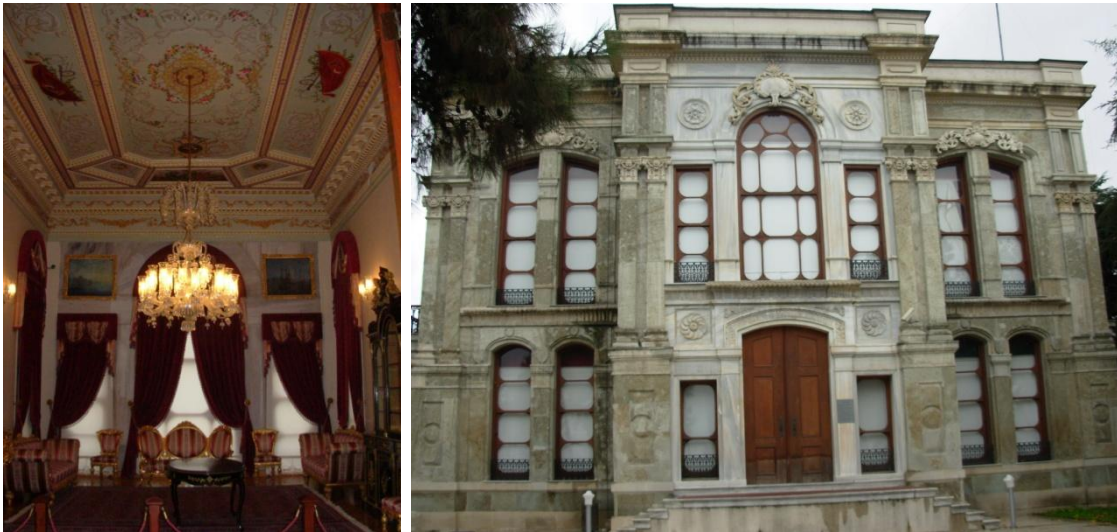
Figure 19. The building in use today as a Palace-Museum , 2012.(Photo. N. Kuban)

Following the completion of the restoration in 2004-2005, the original furniture removed following the earthquakes in 1999 was returned from storage. The Imperial Hunting Lodge became a “Palace-Museum” according to the restoration project and was opened to the public in 2007. (Figure 19)
