Structural evaluation of traditional masonry buildings during the February 6 - 12, 2017 Ayvacık (Çanakkale) earthquakes in Turkey

Caner Göçer

gocercan@itu.edu.tr • Department of Architecture, Faculty of Architecture, Istanbul Technical University, Istanbul, Turkey

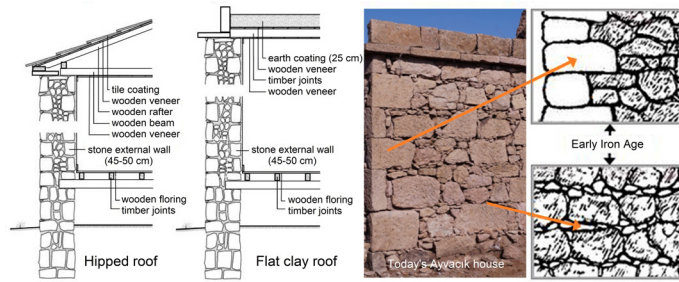
Figure 3. System cross-section of today's Ayvacık houses and similarities of wall bonding technic between traditional Ayvacık houses and the houses of the Early Iron Age.

The houses in today's Ayvacık exhibit various similarities to the historical residential architecture of the region. These similarities point to historical continuity and the most significant can be seen in the system of masonry wall bonding used in external walls. The large stones (elbow stones) used in the Early Iron Age in Western Aegean and Mediterranean houses to ensure strength and stability were widely used, albeit not completely throughout the region (Eran, 1994). Designs were formed on the surface of the wall by placing small stones in between the rubblestone (Figure 3).
